## General Information

Property Address \*\*29 Zelpura Road  
 City Kelso State WA Zip 986\*\*  
 Contact Name Evan Belquist  
 Phone 360-908-3312 Fax 3605725699  
 Client Name Evan Belquist  
 Client Address \*\* 29 Zelpura Road  
 City Kelso State WA Zip 986\*\*  
 Phone 3609083312 Fax 3605725699  
 E-Mail EBelquist\_21@Comcast.net  
 Inspector Name Mindy Smith  
 Phone 3605760053 Fax 3605465815  
 E-Mail CPInspections@MSN.com  
 File Number BEL5628  
 Amount Received \$310.00  
 Others Present Buyer's Agent and Buyer Property Occupied Occupied  
 Estimated Age 15 Entrance Faces Northwest  
 Inspection Date 4/15/06  
 Start Time 10:00am End Time 1:00pm  
 Electric On  Yes  No  Not Applicable  
 Gas/Oil On  Yes  No  Not Applicable  
 Water On  Yes  No  Not Applicable  
 Temperature 70 degrees  
 Weather Partly cloudy Soil Conditions Dry  
 Space Below Grade Basement  
 Building Type Single family Garage Detached  
 Sewage Disposal City How Verified Visual Inspection

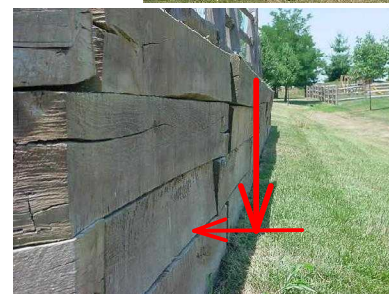
3. **Acceptable** Patio: **Pebble top**
4. **Defective** Deck: **Treated wood** The deck has been built below acceptable building standards and is not safe in its current state. Recommend further evaluation and estimate to bring deck up to an acceptable building standard.

5. **Acceptable** Balcony: **Concrete**
6. **Acceptable** Porch: **Concrete**
7. **Marginal** Vegetation: **Shrubs with some weeds**
8. **Marginal** Retaining Walls: **Railroad ties** The wall is showing signs of movement, but appears to be stable at this time. A qualified contractor is recommended to evaluate and estimate repairs to maintain the wall.

9. **Acceptable** Basement Stairwell: **Concrete**
10. **Acceptable, Defective** Grading: **Moderate slope** The grade and landscaping materials are too high and extend above the window well at the Northeast rear of the home. Recommend that the grade be reduced or the metal window well soil retainer be replaced with a taller unit to keep the mulch and soil beds from washing into the well.

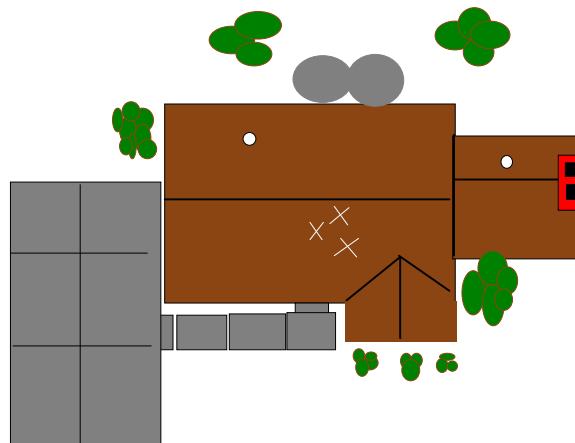
1. **Method of Inspection:** On the roof
2. **Not Inspected** Unable to Inspect: 30% Height of the roof
3. **Defective** Material: Fiberglass shingle Missing roof shingles from wind damage as marked "x" in diagram. Repairs are required.
4. **Type:** Gable
